Case 385 : Narrative

Case Vehicle (A): 2000 Chevrolet	Vehicle (B): 1996 Dodge
Type: Tahoe, 4 x 4, 4-door SUV	Type: Stratus, 4-door sedan
Driver: 69-year-old male	Driver: 17-year-old male
CDC: 01-FDEW-2	CDC: 10-LYAW-3

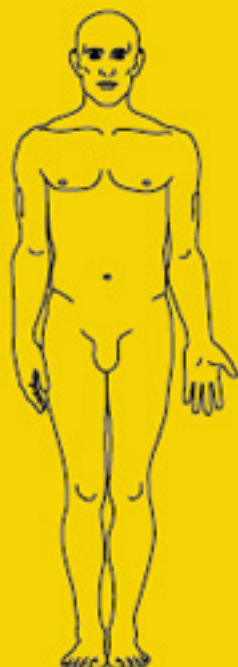
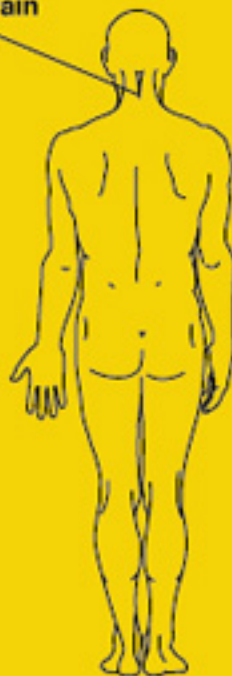
Cervical strain
(1)

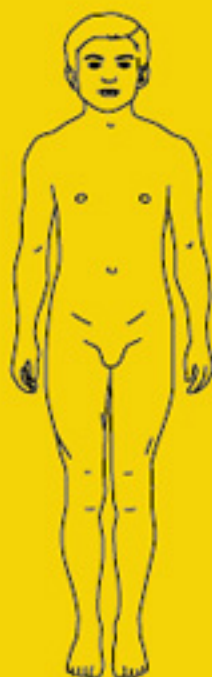
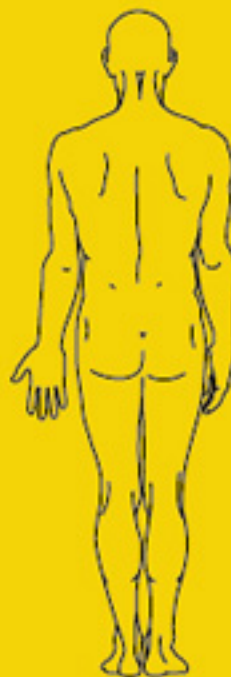
No injury
